## Letter of No Objection for fuel additive Green Plus Combustion Catalyst

<b>REPORT</b>			
Name of Vessel:	<b>MAERSK ARUN</b>	IMO No:	<b>9175779</b>
Name of Yard:	<b>China Shipbuilding Corp.</b>	Hull No:	<b>678</b>
Engine Type:	<b>7S50MC</b>	Sea Trial:	<b>199 03 01</b>
Visit by:	<b>GSM 2300</b>	Service Center:	<b>Copenhagen</b>
Engine Builder:	<b>HITACHI</b>	Engine No:	<b>3776</b>
Order No:	<b>40 003 320</b>	Run. hours:	<b>32906</b>
Place:	<b>Varna, Bulgarian</b>		
Period:	<b>2005 09 17</b>		
Owner:	<b>The Maersk Company Co Ltd</b>		
Requested by:	<b>Biofriendly Corp.</b>		
Reason:	<b>Inspection after running with Green Plus fuel Additive</b>		
Keywords:

M/V MAERSK ARUN 7S50MC IMO 9175779  
Varna, Bulgarien 2005 09 17

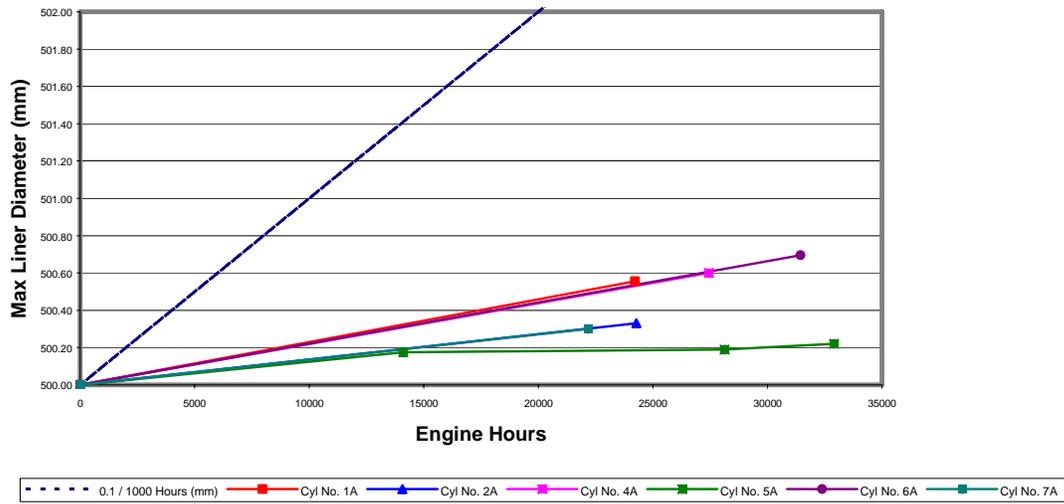
Max. Liner Diameter Analysis  
MAERSK ARUN HITACH-003776

The liner was in good condition with no machining marks visible. The max. wear was found at top of liner in ring 2, top dead centre and was 0.22 mm, i. e. 0.007 mm/1000h from new and the same as since last overhaul, as seen below.. Wear edge at ring 1 in TDC was ground away.

The inspection from exhaust side shows good condition for all units as seen on the picture, all are more or less alike, but with different running hours as seen on page 4. All piston rings were in good condition and with shape as seen on page 4. All liners were with machining marks slightly visible in the inspected area, at manoeuvring side and the max. wear for all liners as seen below.

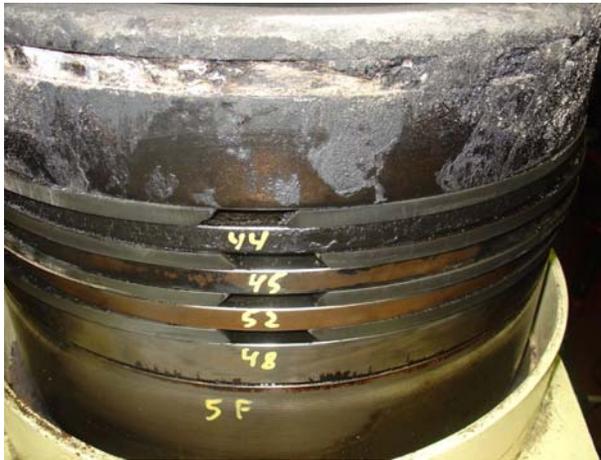
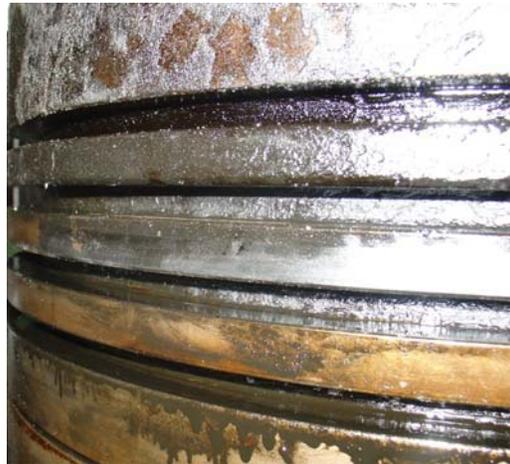
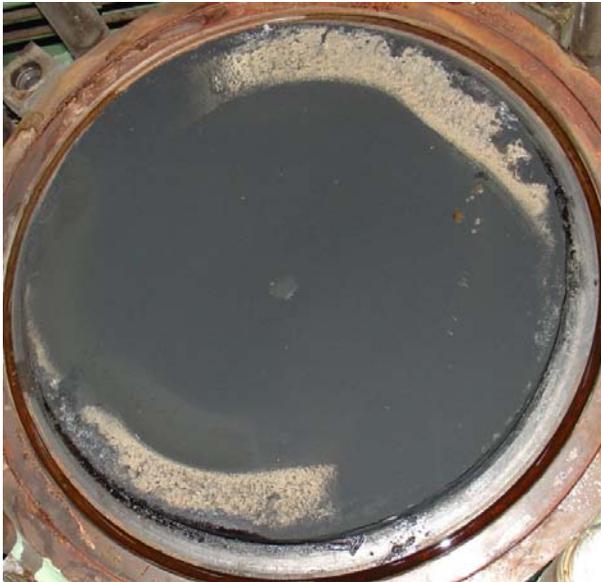
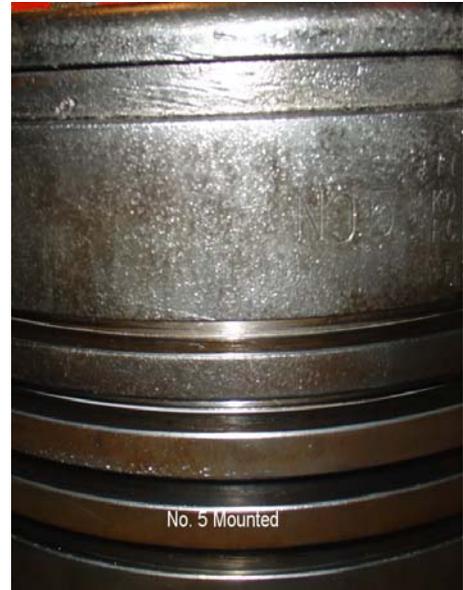
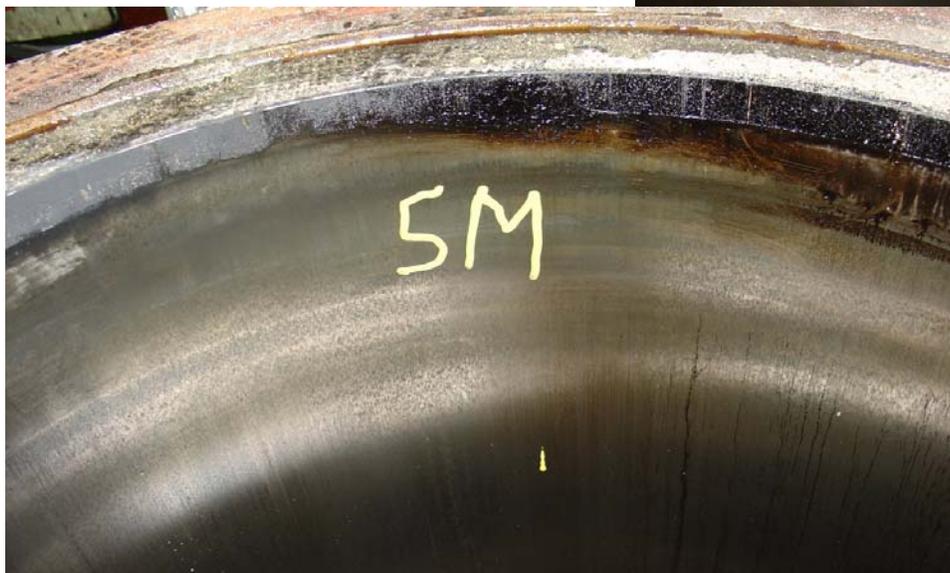
The piston was in good condition with medium carbon on topland and light carbon on ringland 1. There was a yellow layer of deposit on top of the piston top, but less than at last inspection. All piston rings were in good condition with only small reduction in the tension. The max. piston ring wear was for ring No. 1 and was 1 mm, i. e. 0.2 mm/1000h. There was only small amount of deposit at the back of the rings and a thin layer at the bottom of the ring, grooves No. 1 and 2. There is only little wear for the ring grooves and no burning of piston. Piston skirt without bronze band in good condition. Spare piston was fitted with Daros RM5 Alu-coated top ring the other Riken 47

The Exhaust valve and Cylinder cover were in good condition.
